**Re: Bumgardner – Dry Bone Road Tire Dump
Notice of Violation (NOV)
NOV
Scrap Tires
Pike County
ST025366**

Subject: Notice of Violation #2 - Open Dumping of Scrap Tires

Bumgardner – Dry Bone Road Tire Dump

ST025366

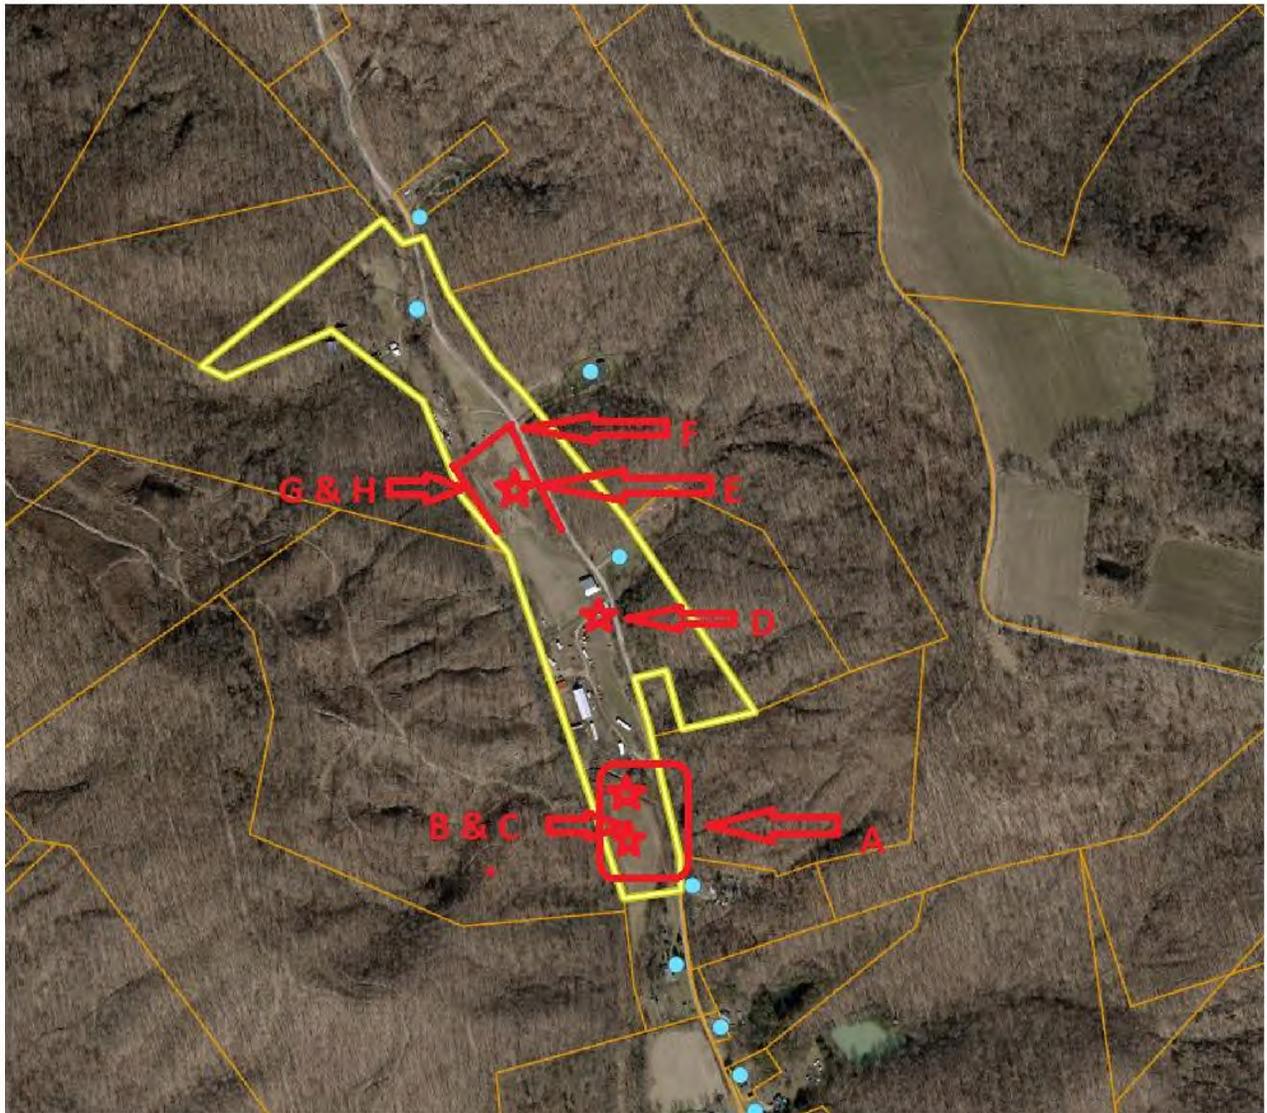
Map of 3496 Dry Bone Road. Parcel #120122000000 is highlighted in yellow. Primary tire locations are highlighted by the red lines and red stars. Red lines highlight how tires are stacked to varying heights on the perimeter of the property, while red stars indicate large piles of the scrap tires.

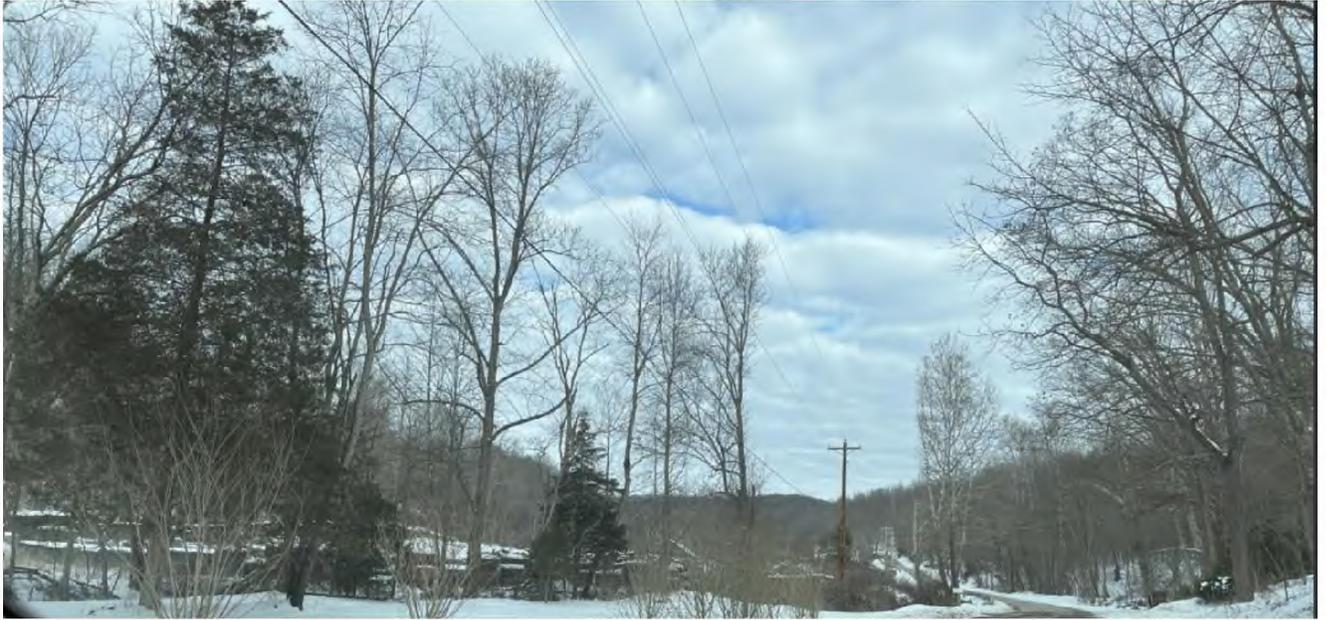
Photo #1 – Bumgardner – Dry Bone Road Open Dump

Point A. Photo taken from south of 3496 Dry Bone Road looking north. Tires in foreground of photo, covered slightly by trees and shrubs.

promptly cause the removal of these tires by a registered scrap tire transporter, dispose of these tires at a licensed scrap tire disposal or recovery facility, and submit verification that these scrap tires are being properly managed.

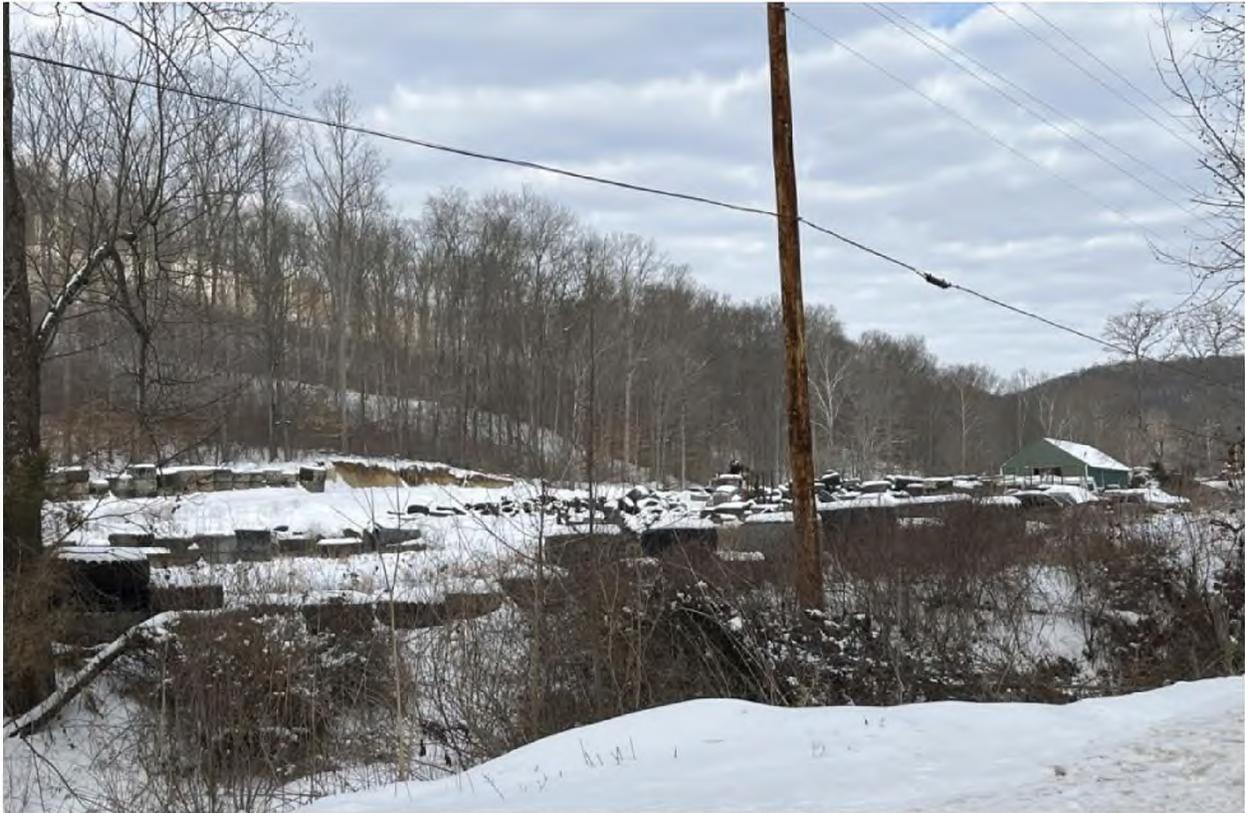
Photo #2 – Bumgardner – Dry Bone Road Open Dump

Points B & C. Tires stacked along perimeter of southern portion of parcel. Large piles also seen dumped in the middle of the field.

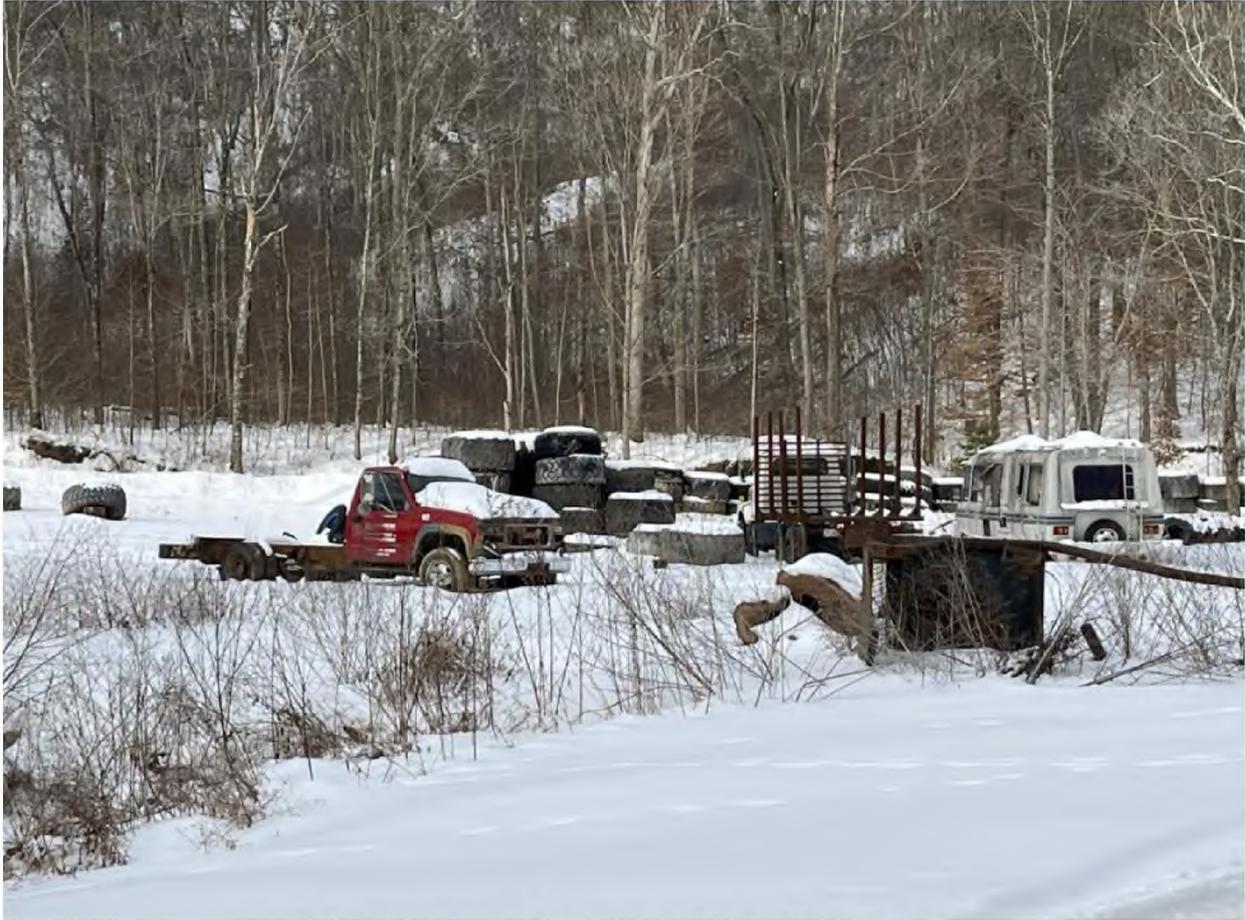
Photo #3 – Bumgardner – Dry Bone Road Open Dump

Another pile of OTR tires in the middle of the property, with additional tires scattered throughout.

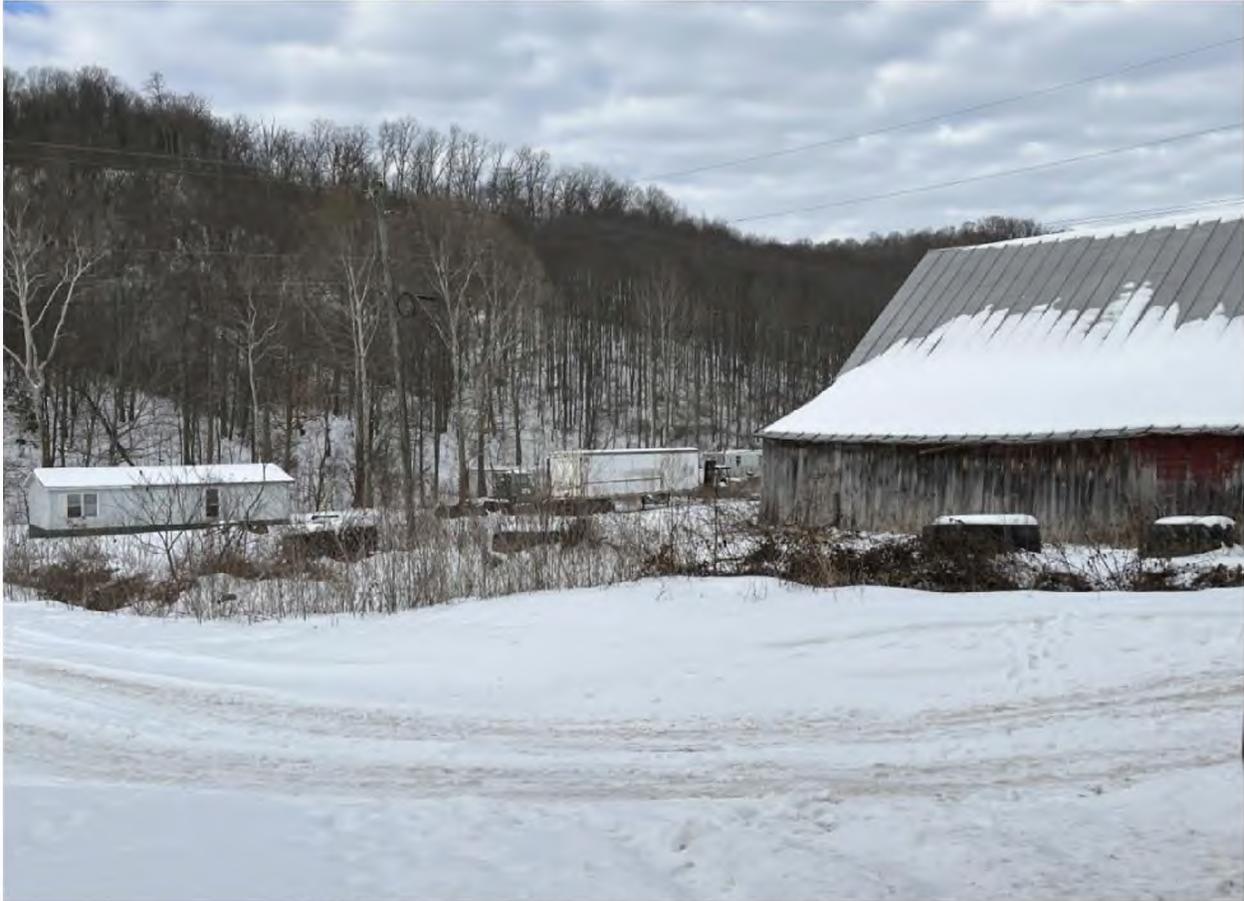
Photo #4 – Bumgardner – Dry Bone Road Open Dump

Point D. More OTR tires stacked around the barn next to the road, with additional tires seen stacked in background next to tractor trailer.

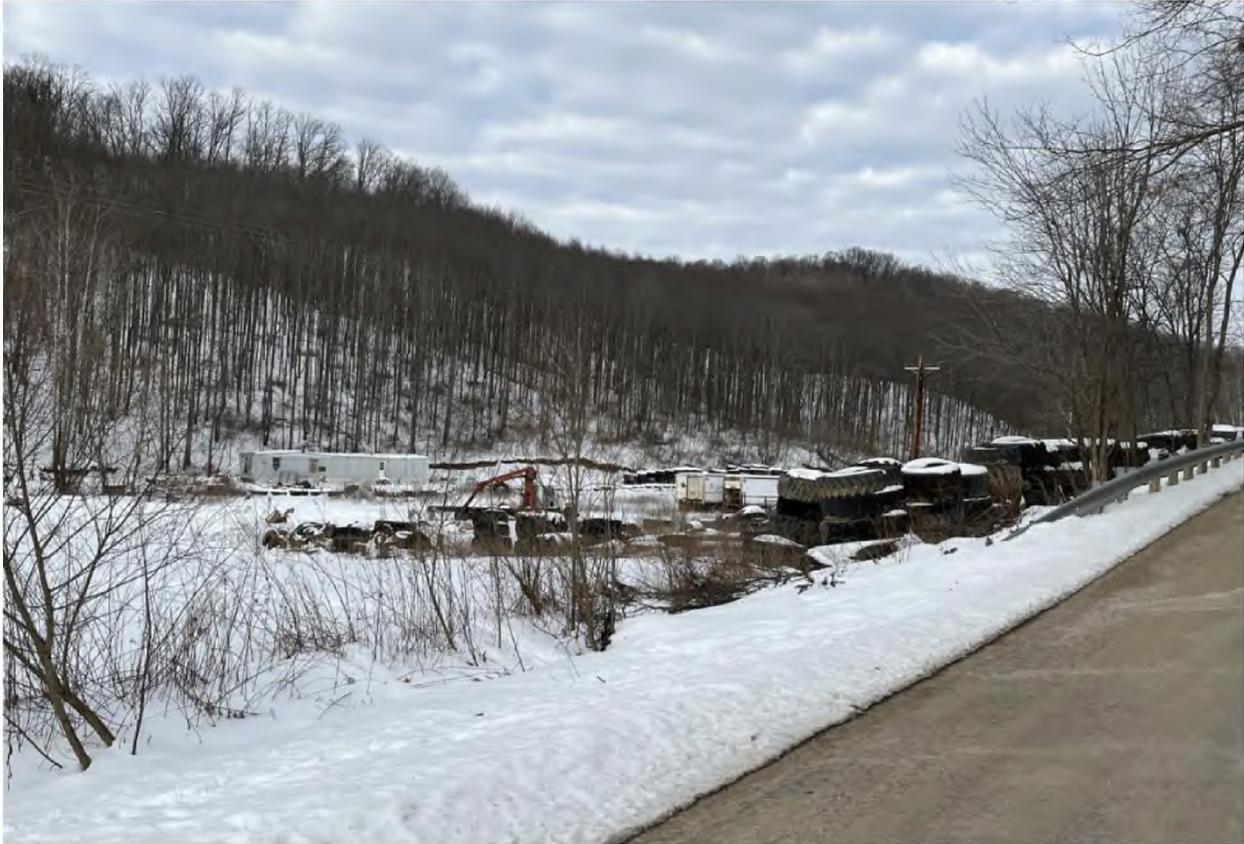
Photo #5 – Bumgardner – Dry Bone Road Open Dump

Point E. Image taken just north of the barn alongside Dry Bone Rd. OTR tires stacked along roadside and back near creek/tree line. Small pile of tires in middle of field as well.

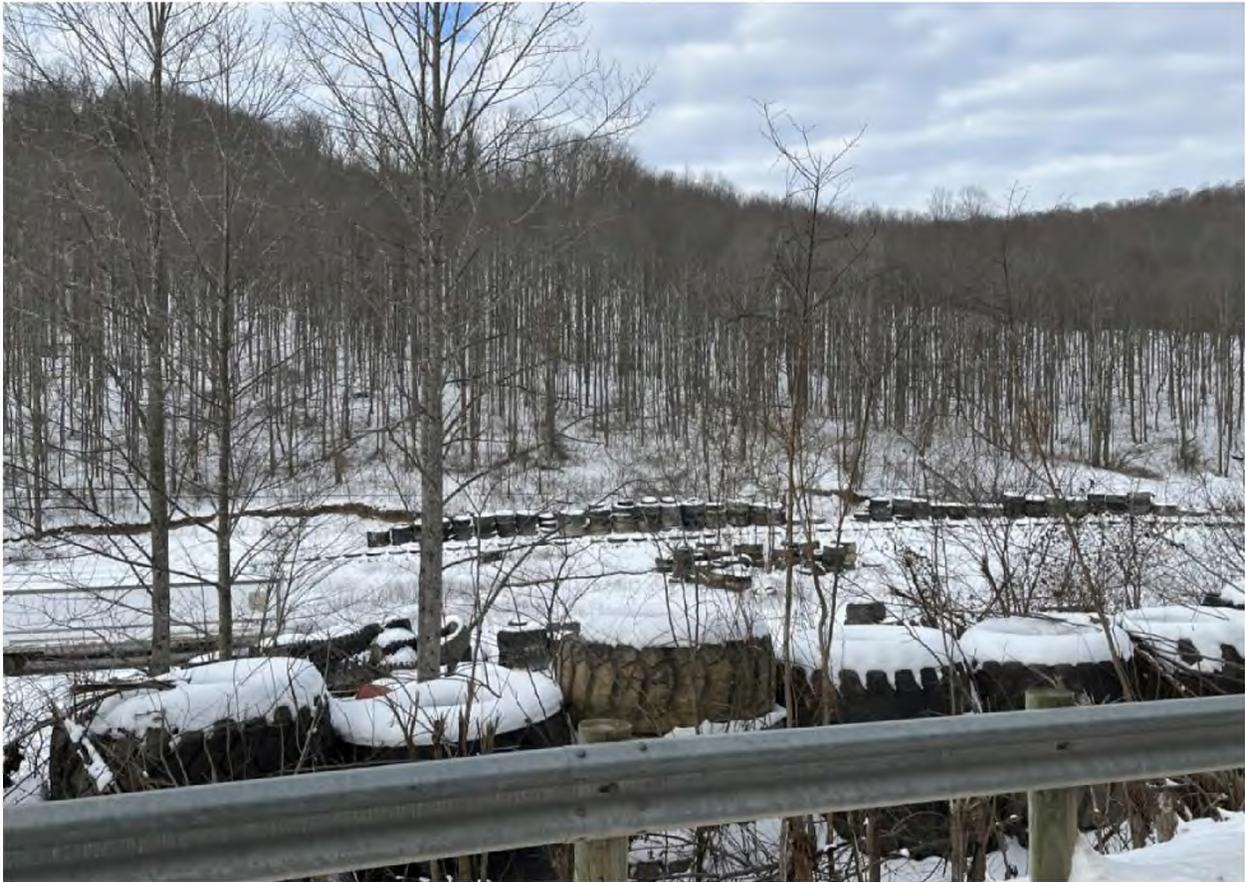
Photo #6 – Bumgardner – Dry Bone Road Open Dump

Points E & F. Image shows more tires stacked along roadside as noted in Photo #5, and highlights point F, where tires have been dumped in piles in the middle of this northern side of the parcel.

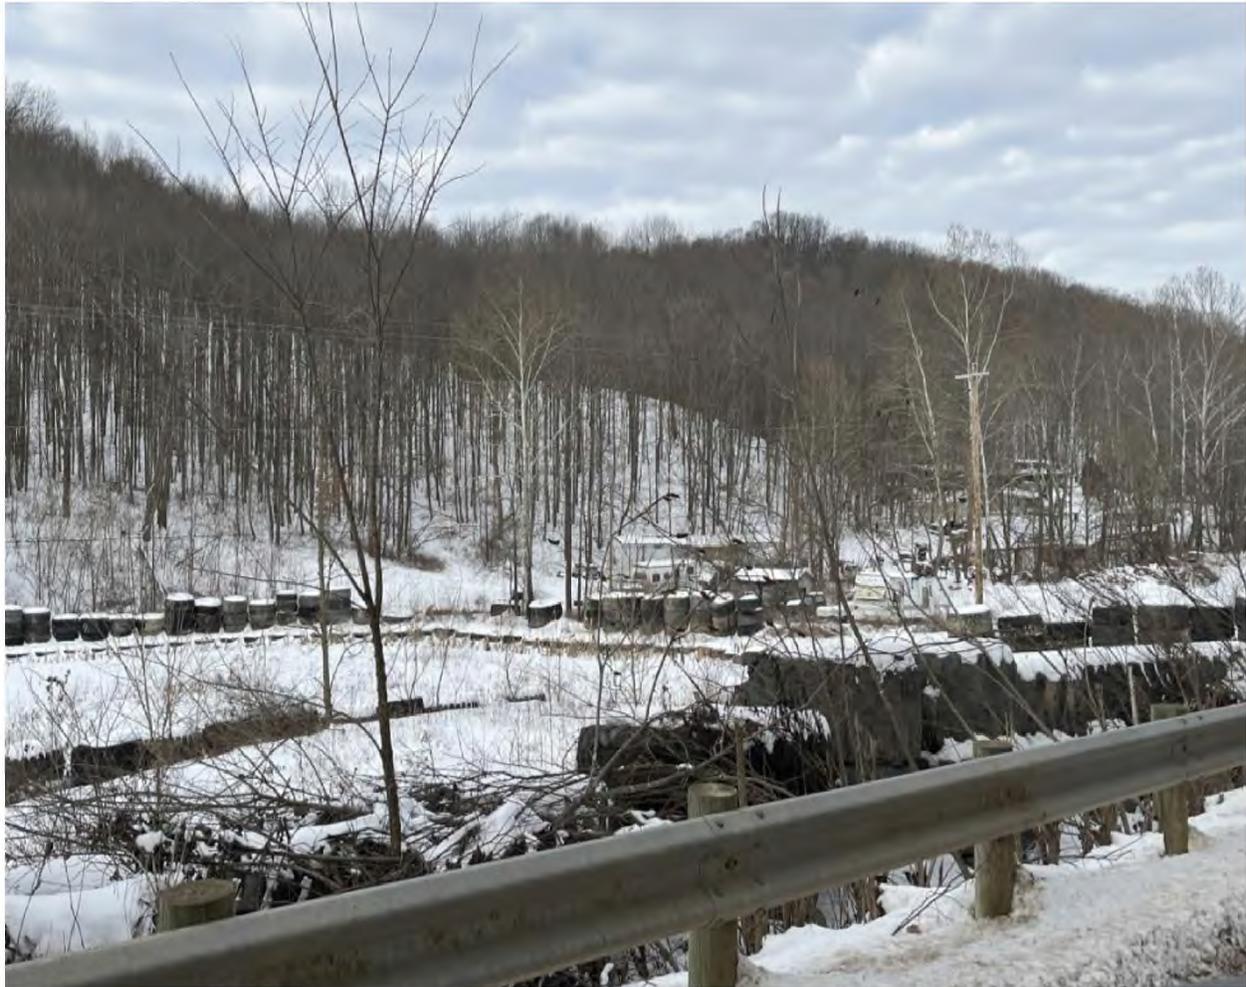
Photo #7 – Bumgardner – Dry Bone Road Open Dump

Points G & H. More OTR tires stacked property perimeter. Shows how tires have been stacked and illegally dumped across the entirety of parcel #120122000000.

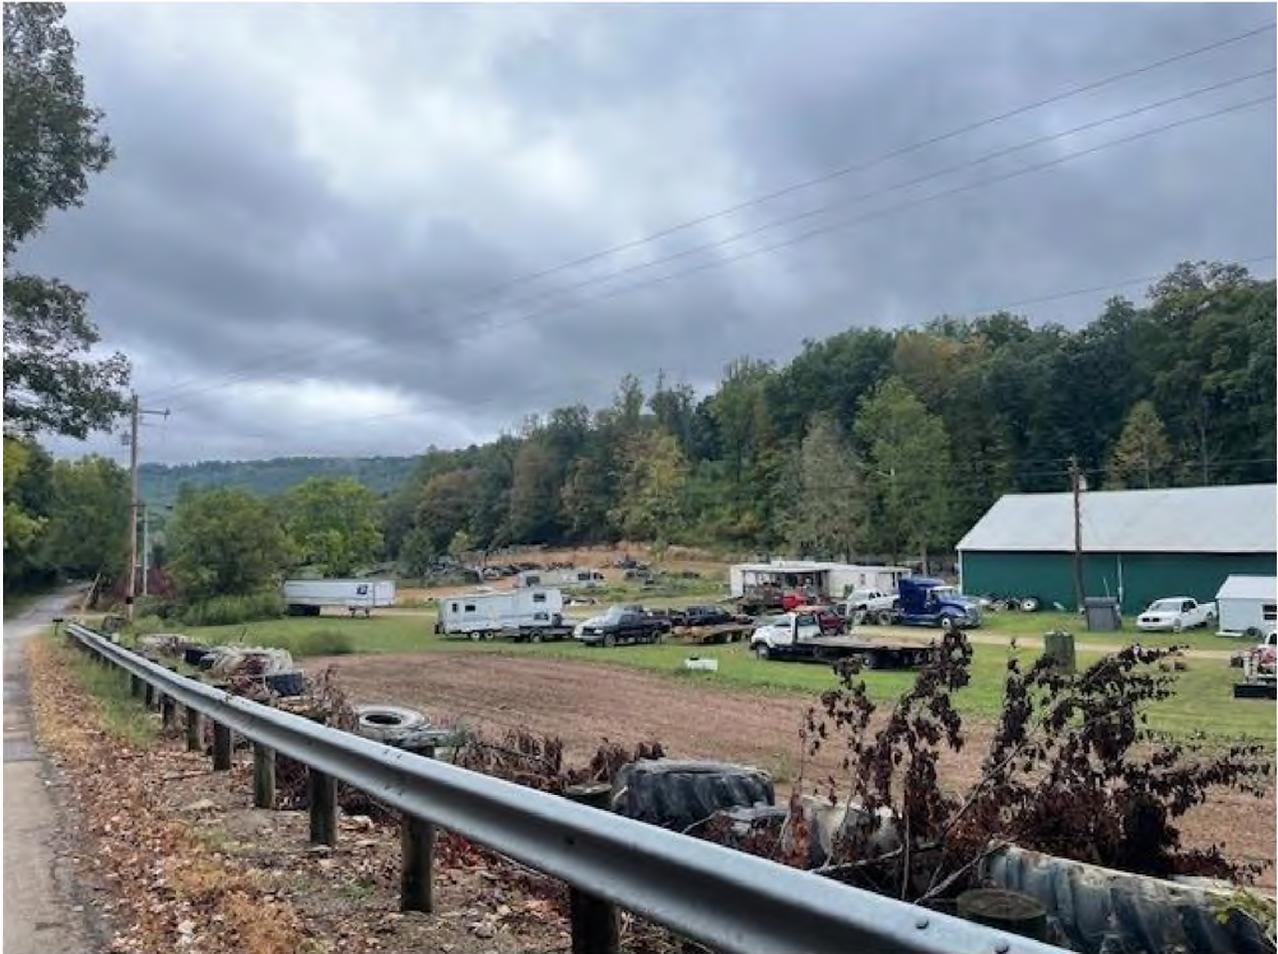
**Photo #8 – Bumgardner – Dry Bone Road Open Dump
9/4/2025 - Photograph taken by: Christian Bradford**

Picture taken toward the middle of the parcel. This image highlights how tires have been stacked along roadside for an extended period of time now.

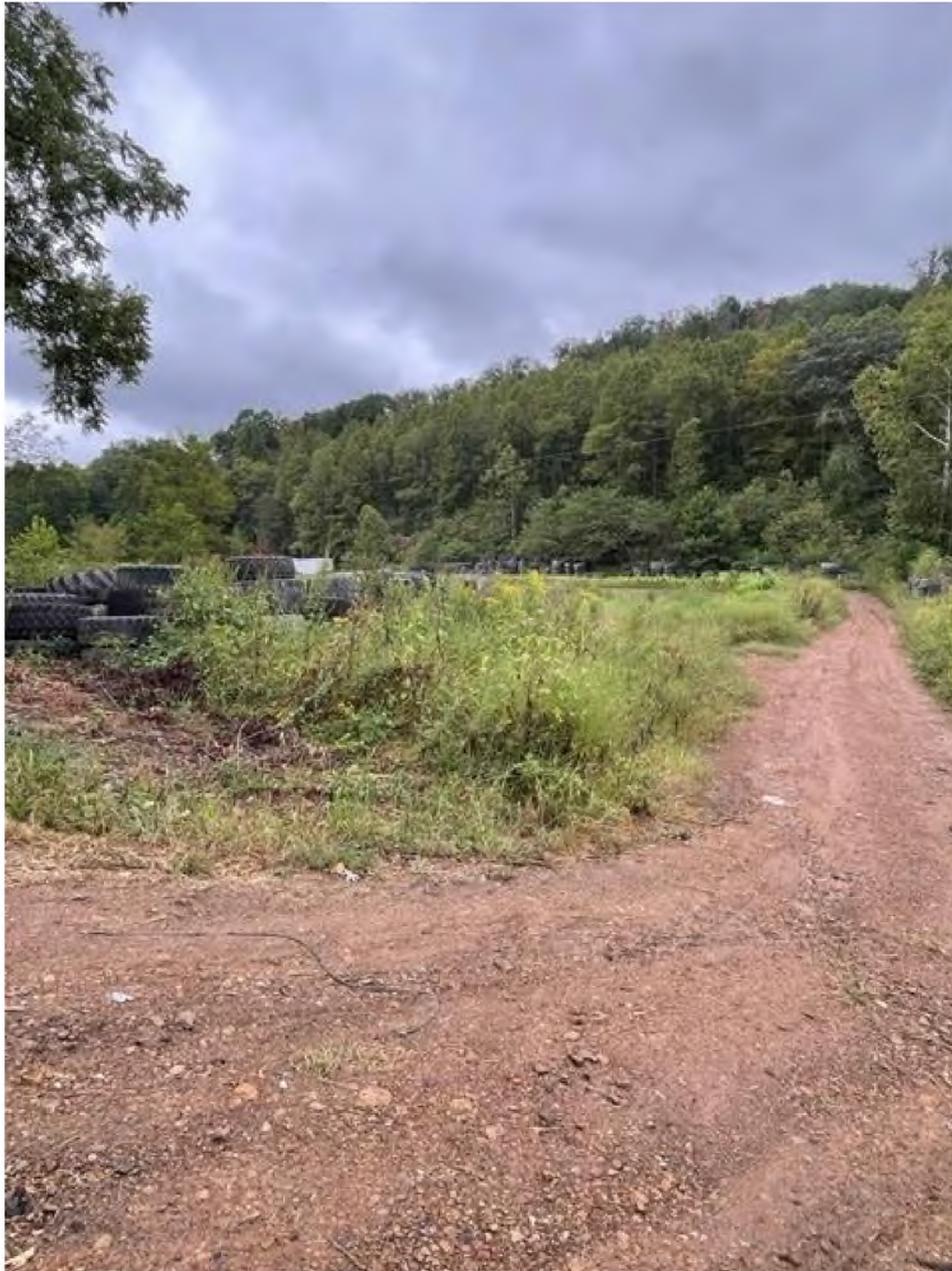
Photo #9 – Bumgardner – Dry Bone Road Open Dump

Picture of tires on northern side of parcel. Taken in similar location to Photo #7, highlighting tires stacked around the perimeter of northern portion of the parcel.

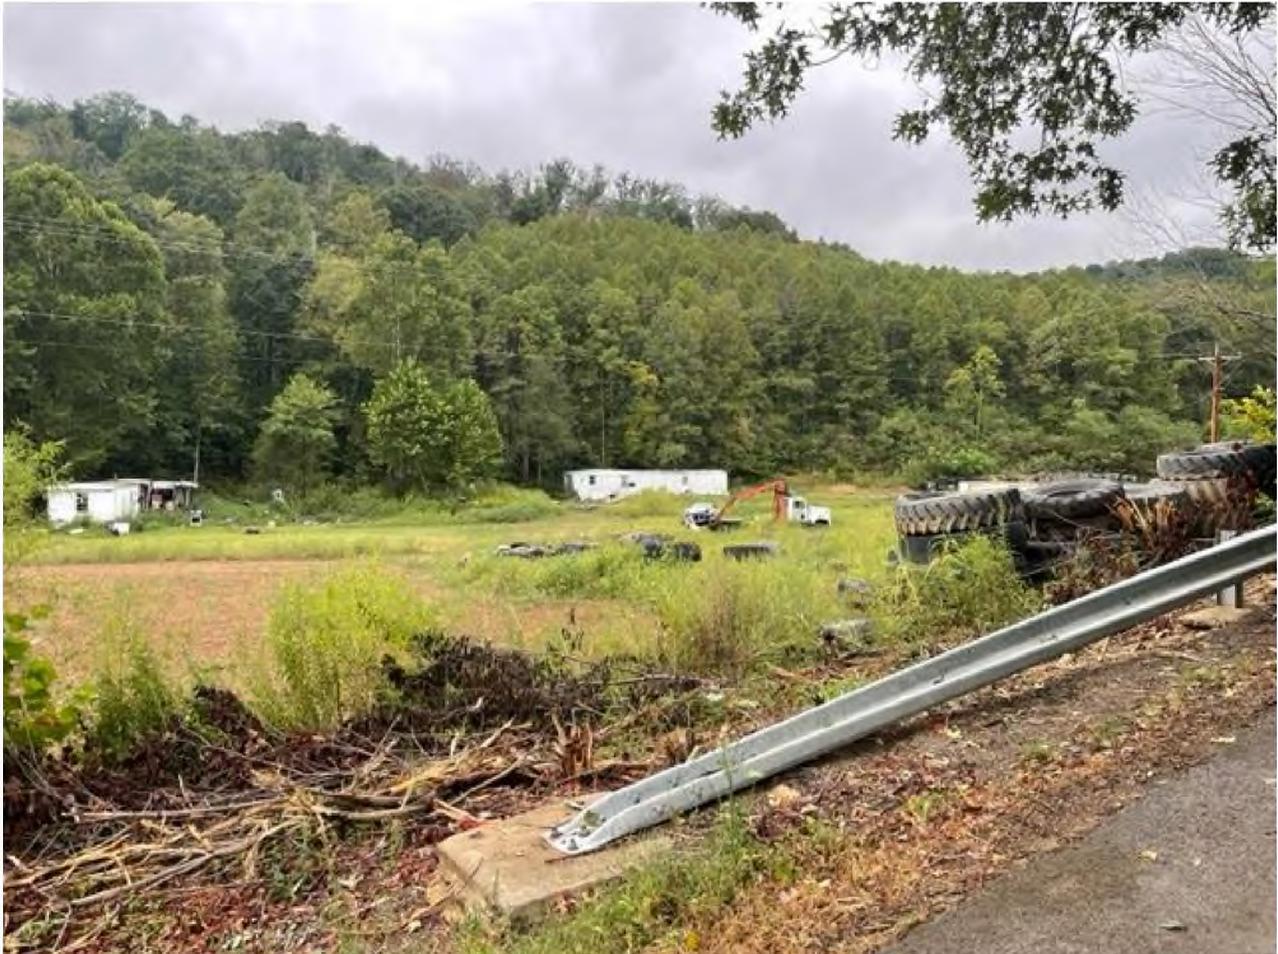
Photo #10 – Bumgardner – Dry Bone Road Open Dump

Compare to Photo #5, as it is from similar location, as boom truck parked in field acts as marker for both images.

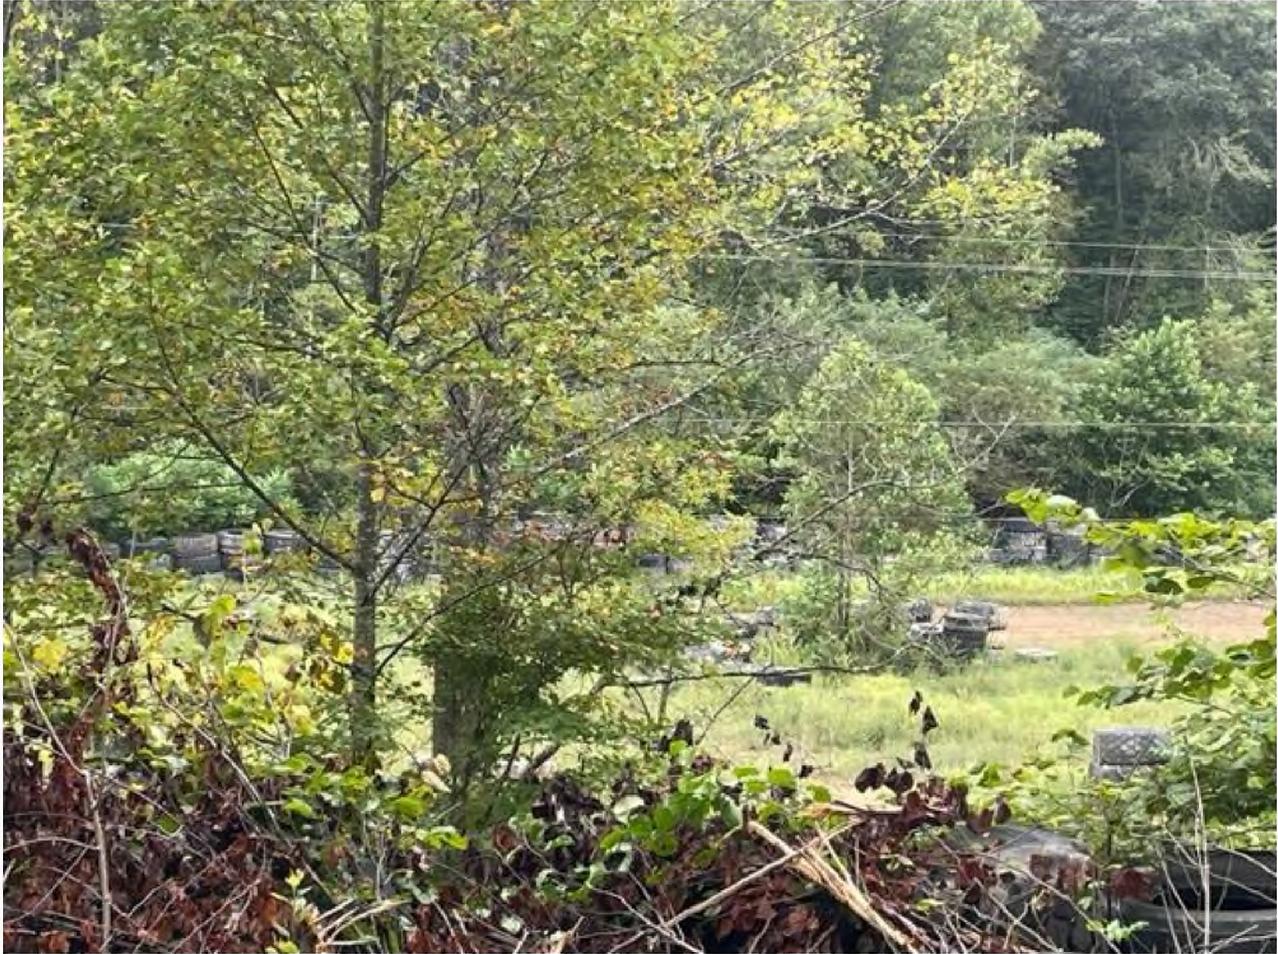
Photo #11 – Bumgardner – Dry Bone Road Open Dump

Picture of tires along tree line. Tires piled up in the middle of the property as well. Taken in similar location as Photo #2.
